Margam

Margam surface mine & Park Slip

Site visit (September 2022)

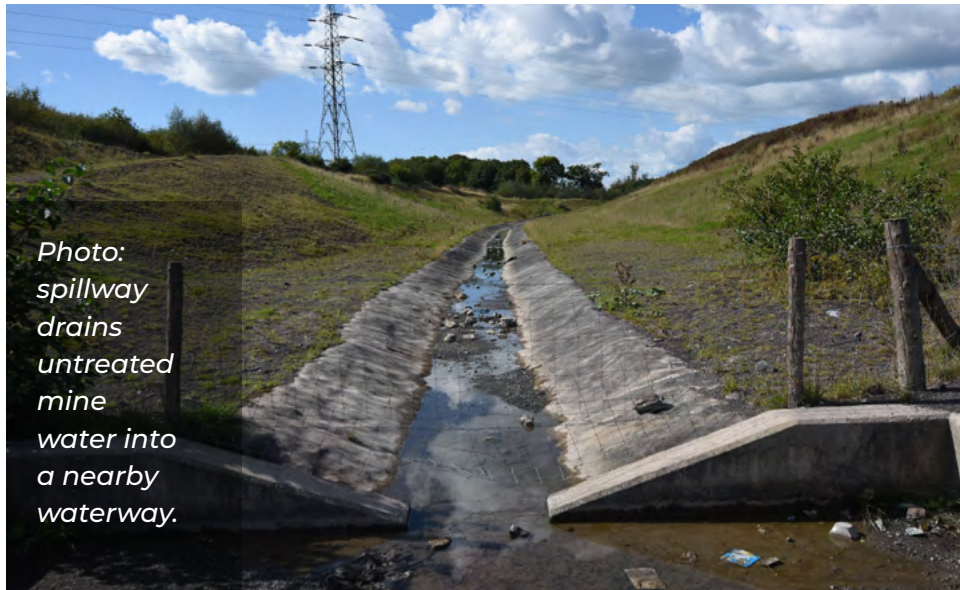
*Photo:
spillway
drains
untreated
mine
water into
a nearby
waterway.*

A spillway maintains the water level in the void at 48 metres above average sea level, preventing flooding. The links along Crown Road and Bedford Road have been re-established to a lower and cheaper standard to what was originally there. Over-burden mounds have been excavated and re-profiled to the minimum amount required. The void area will remain fenced off to deter access. Footpaths have been reinstated along other routes due to the water-filled void. Some areas have naturally revegetated—these will not be substantially interfered with, with aftercare focused on this area.

This is how an agreed restoration originally estimated at £58 million was downgraded to a £5.7 million project, much of which was allocated to constructing a spillway to prevent the risk of catastrophic flooding. That flood risk was the result of Celtic Energy Ltd turning off their pumps that discharged water out of the void after mining ceased and, over the years of legal battles, the void filling with 11 million cubic metres of water. Celtic Energy Ltd then engaged pumps in 2015 to prevent the water level rising further but indicated this would be for a limited time only.

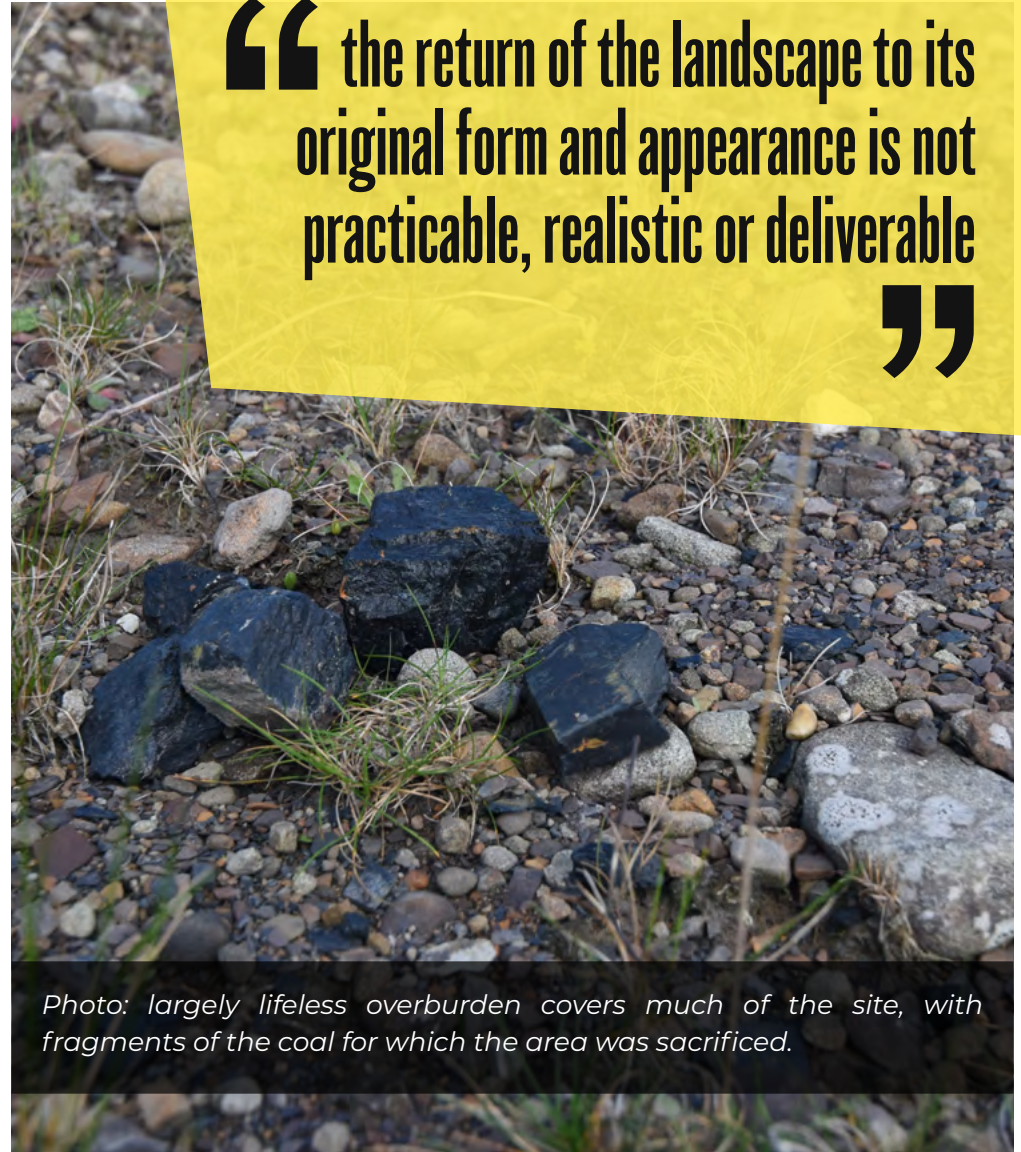
The report from a site visit found a raised overburden mound with stony soil and little in terms of revegetation. The surrounding area is covered in shrubs and small trees except where smaller mounds of similar stony soil remain. The steep-sided coal face is exposed on one side where a lake now exists in the void. The water has a slight iridescence to it and there is no sign of life. A wire fence surrounds the lake, but is broken down in at least one place. Ditches run from the large overburden mound to feed into the lake, with a concrete spillway in one corner to prevent flooding.

Photo: largely lifeless overburden covers much of the site, with fragments of the coal for which the area was sacrificed.
