Tower

Tower Colliery Railhead

Site visit (September 2022)

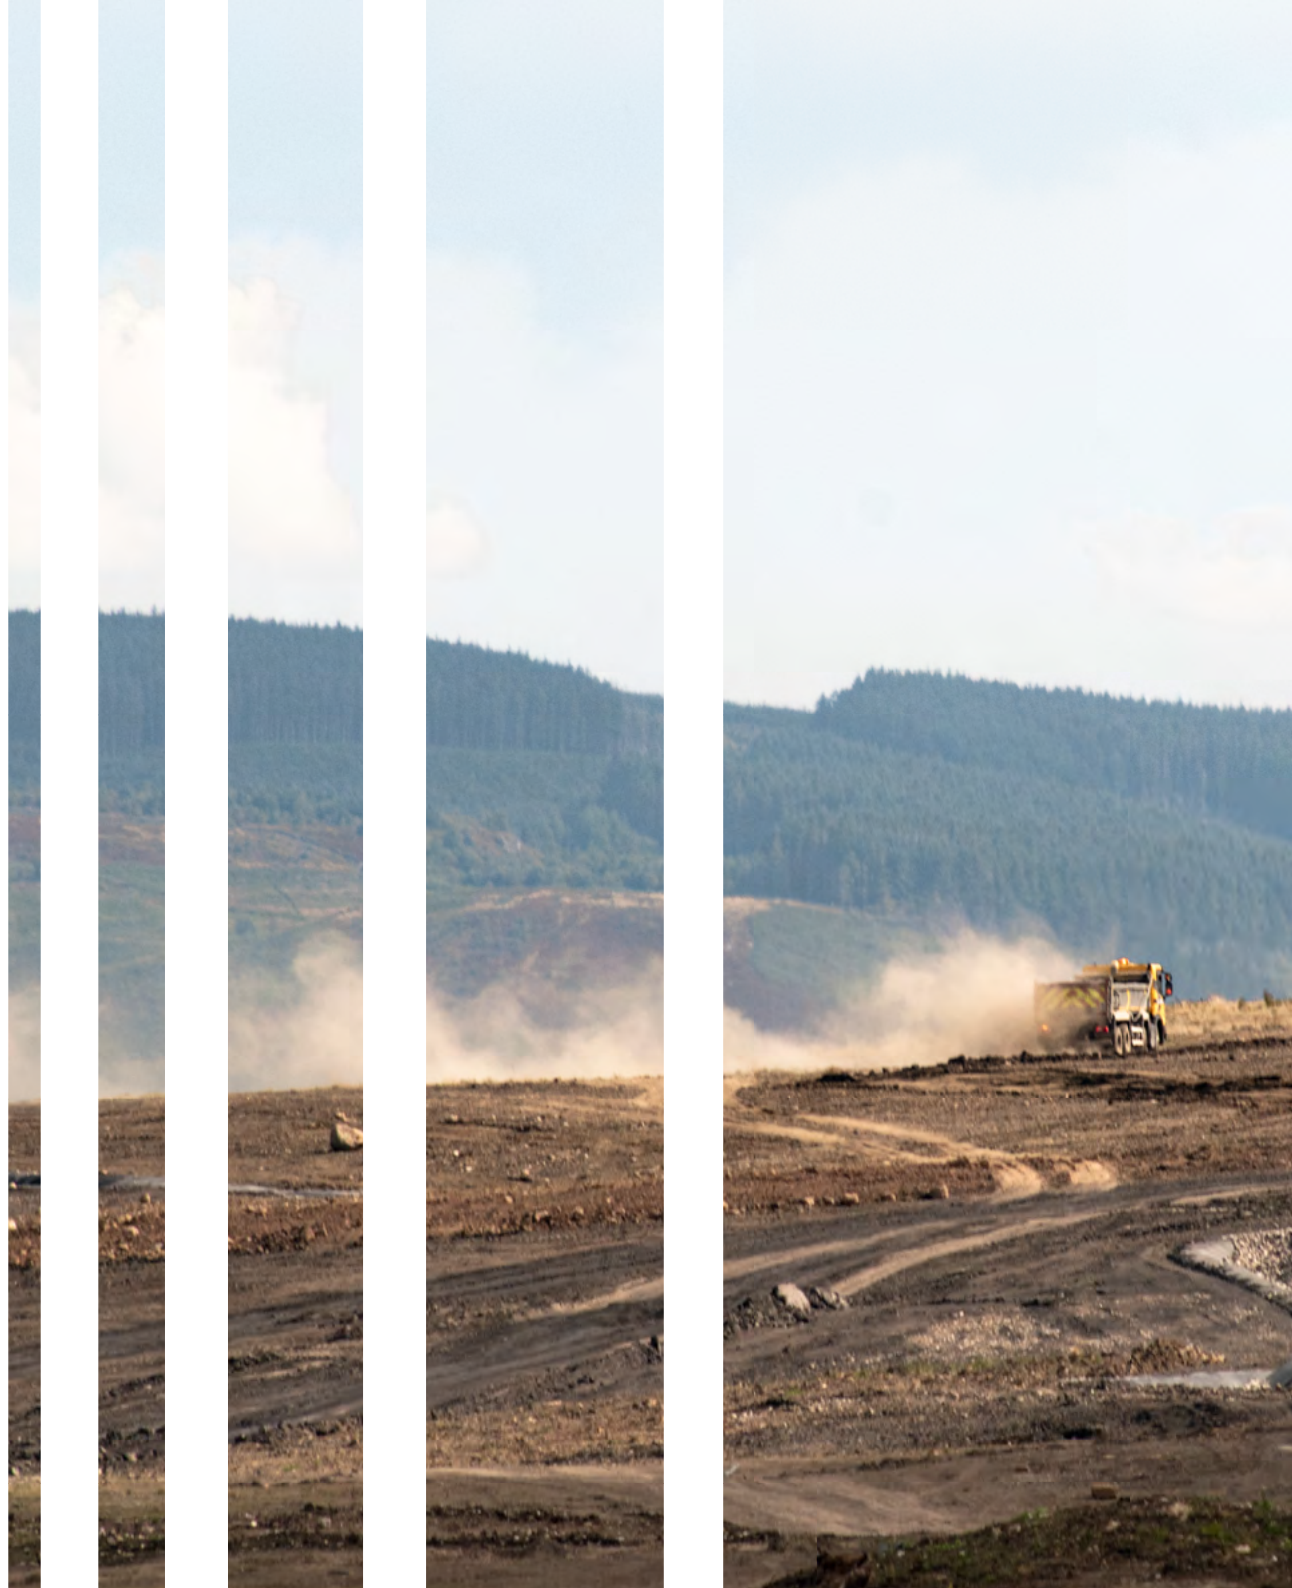
The report from a site visit described ongoing restoration: a large, fairly level area of exposed soil with several vehicles working on it, and a digger reprofiling a hill that slopes onto the level area. Sharp, vertical cuts into the slope are still visible. Large amounts of airborne dust was visible from heavy vehicle movements on the exposed soil. No remaining void could be seen.
